## Starry Stonewort Searches for Clearwater Lake, Wright County, Minnesota, 2020

Survey Dates: July 10 and September 30, 2020

Prepared for:  
Clearwater Lake Property Owners

Prepared by:  
Steve McComas,  
Jo Stuckert, and  
Connor McComas  
Blue Water Science,  
St. Paul, MN

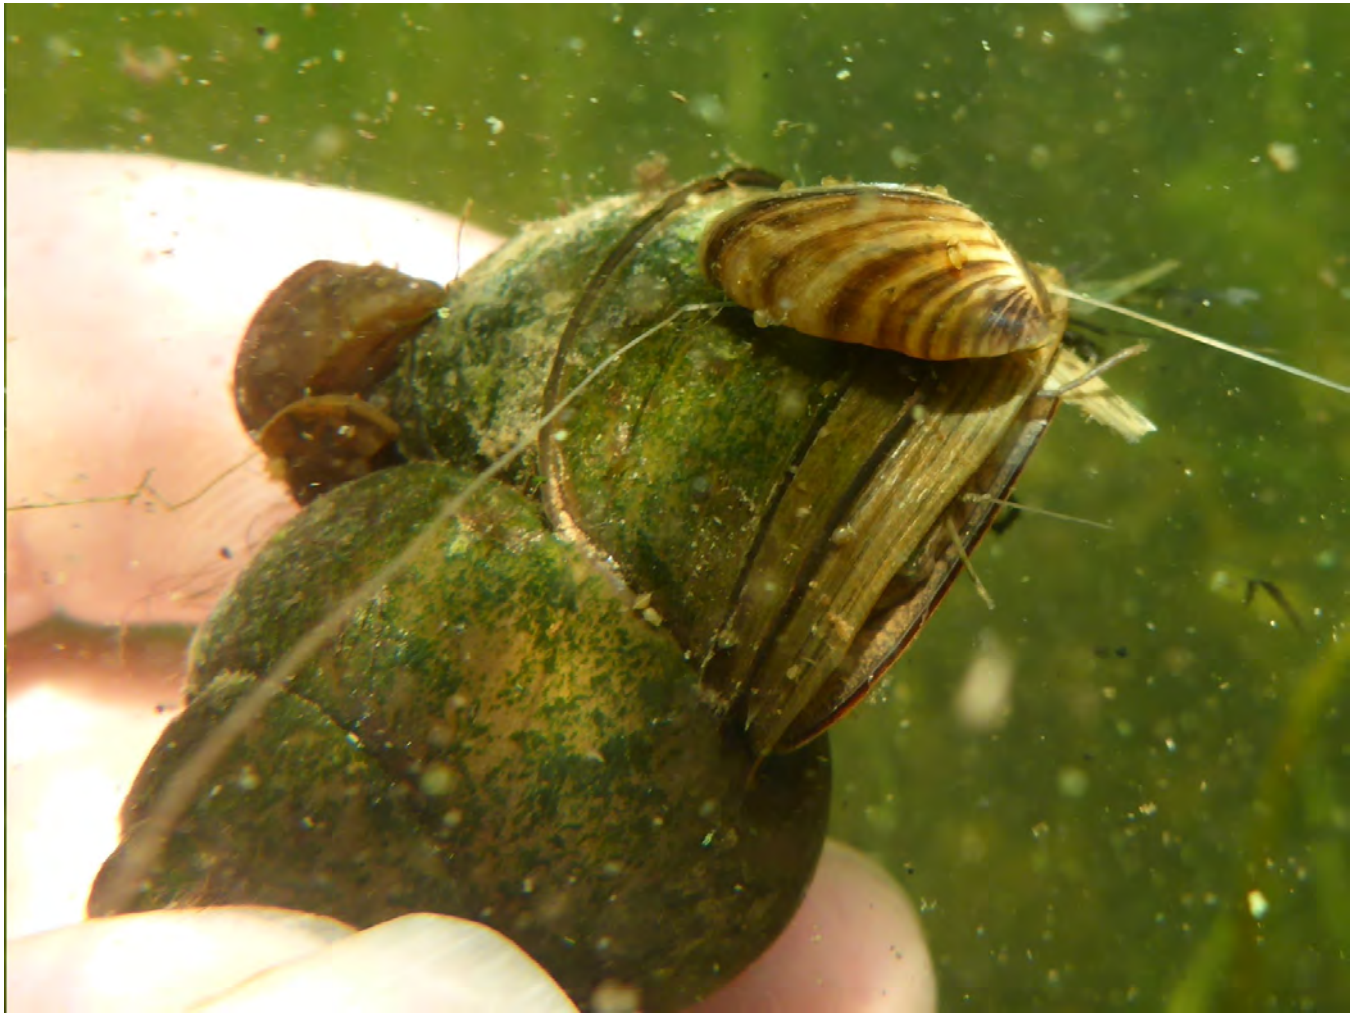
Chinese Mystery Snail with Zebra Mussels Attached in Clearwater Lake on July 10, 2020

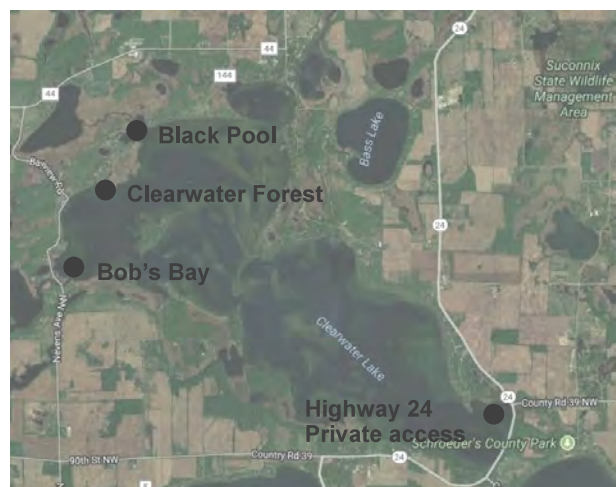
**Figure 1. Location of the access search sites.**

**Summary of the 2020 searches:** Two staff from Blue Water Science, surveyed 4 boat accesses on July 10, 2020 (Figure 1). A combination of rake sampling (205 rake samples) and scuba diving (a total of 3.2 search hours) were conducted (Table 1). No starry stonewort was observed at any location.

On September 30, 2020 three staff from Blue Water Science surveyed 4 boat accesses. A combination of rake sampling (164 rake samples) and scuba diving (a total of 3.3 search hours) were conducted (Table 1). No starry stonewort was observed at any location.

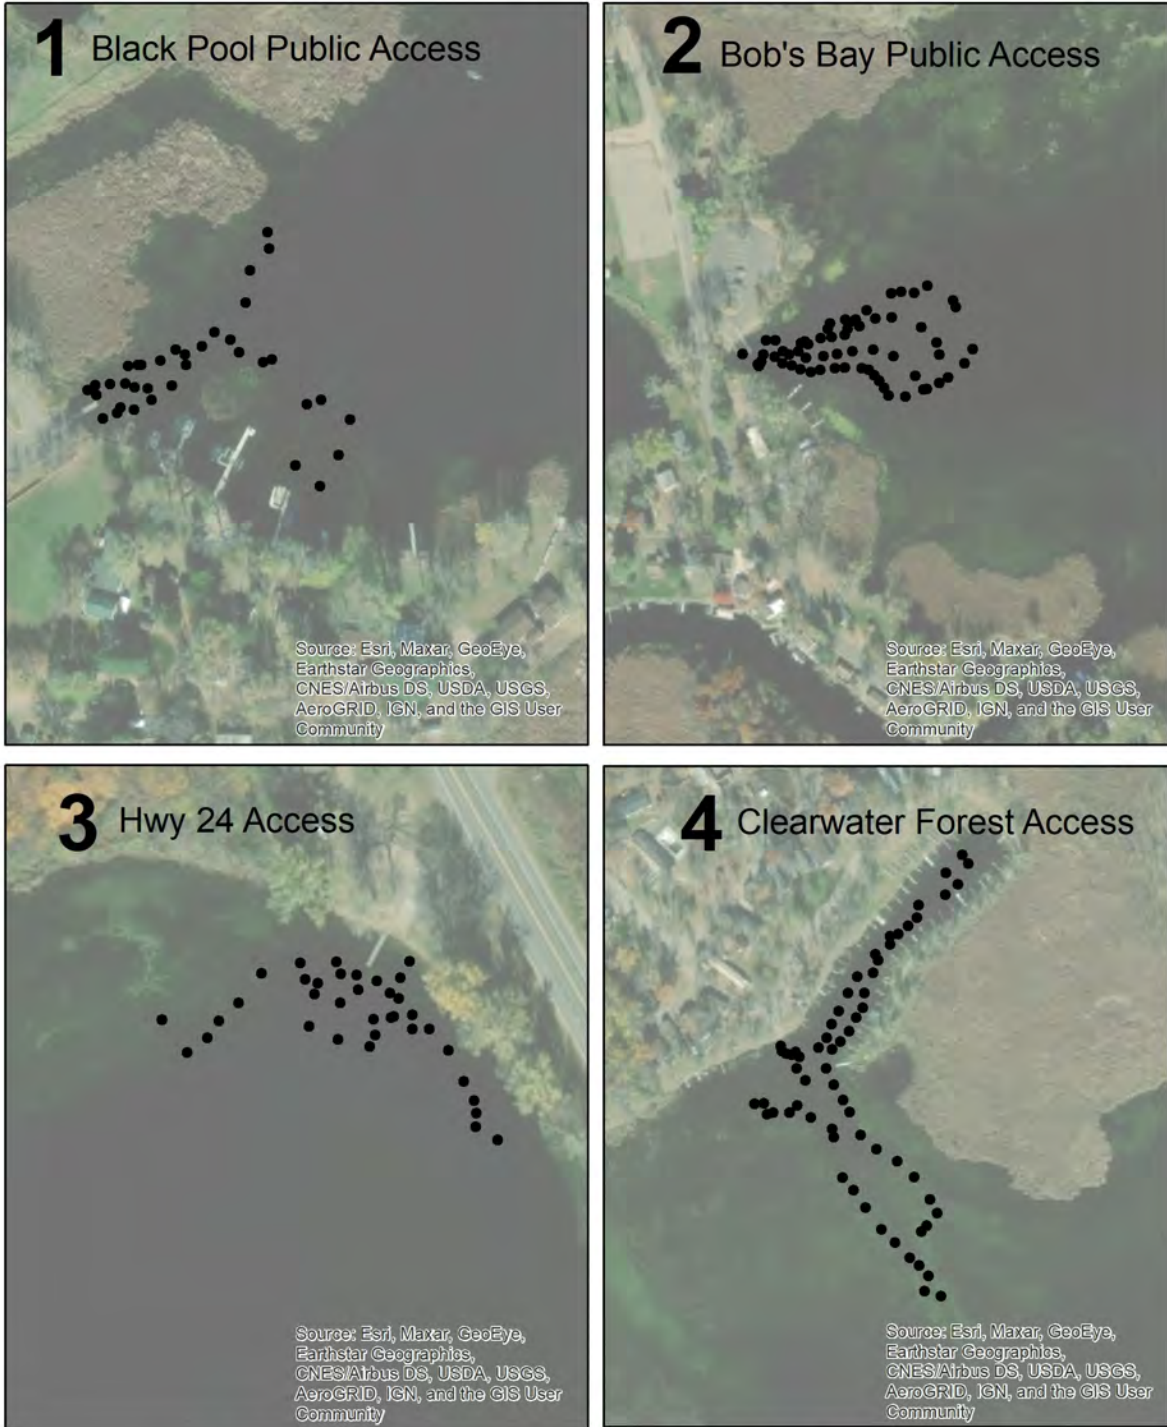
Figure 2. Survey areas for July 10, 2020 (dots on maps 1, 2, 3, and 4 indicate rake sample locations).

**No Starry Stonewort Observed on July 10, 2020**

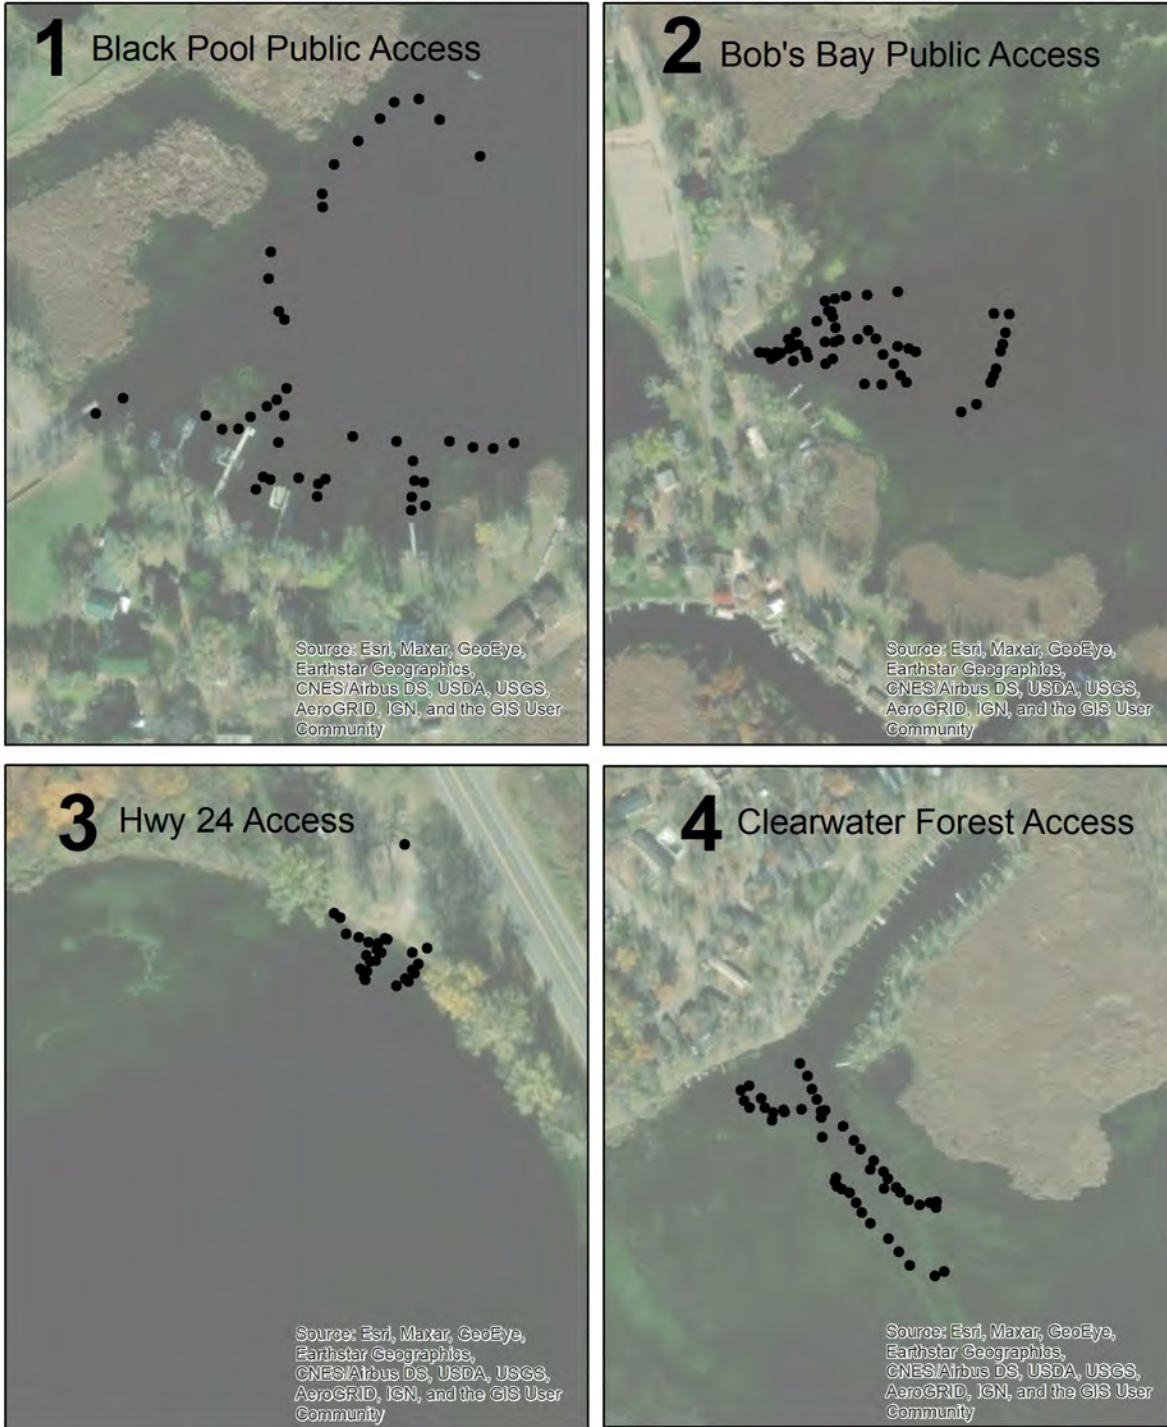
Figure 3. Survey areas for September 30, 2020 (dots on maps 1, 2, 3, and 4 indicate rake sample locations).

**No Starry Stonewort Observed on September 30, 2020**

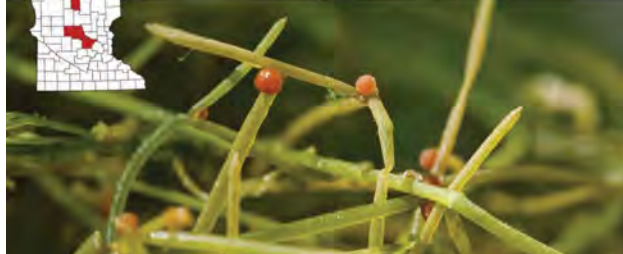
Actual size of bulbils  
Below, orange antheridia

Figure 4. [left] Starry stonewort identification page from the University of Minnesota Aquatic Invasive Species Research Center (MAISRC). [right] Starry stonewort from Lake Koronis on July 31, 2017.

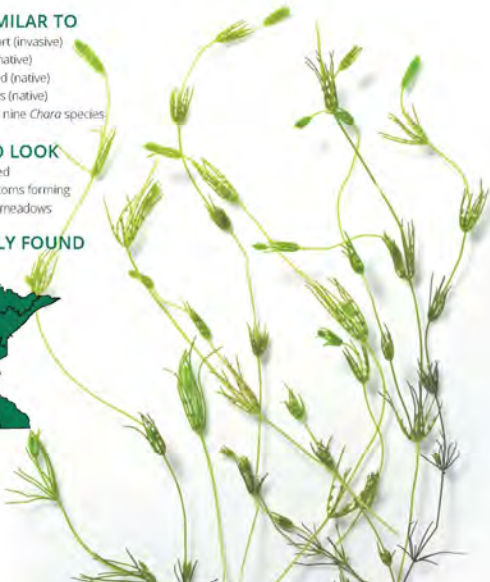
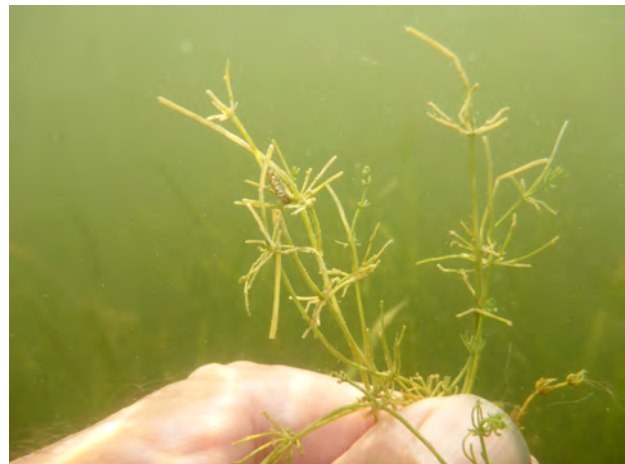
Rough stems; whorled branchlets

Figure 5. [left] *Chara* identification page from the MAISRC. [right] Starry stonewort looks a lot like some growth forms of chara. Starry stonewort was not observed in Clearwater Lake in 2020. The photo is chara from Clearwater Lake.

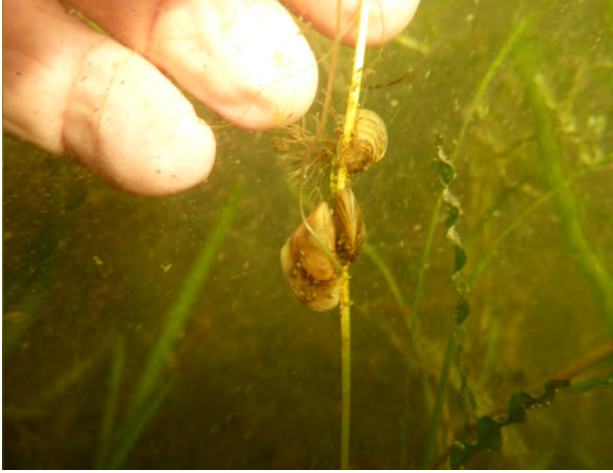
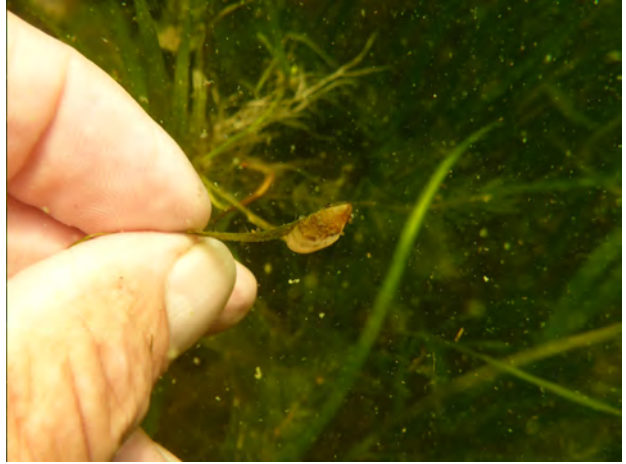
**July Conditions: Adult zebra mussels were found growing on aquatic plants at the access areas.**

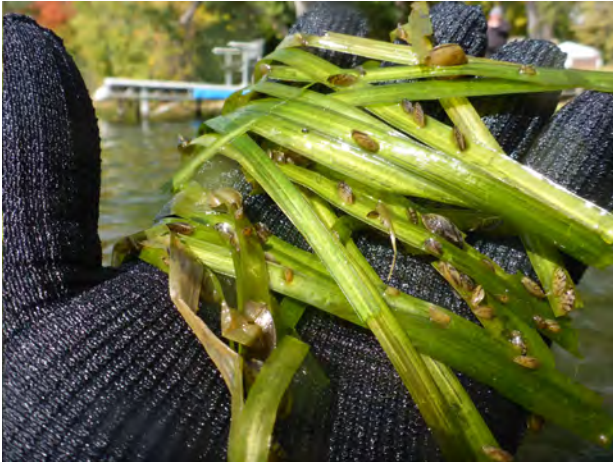
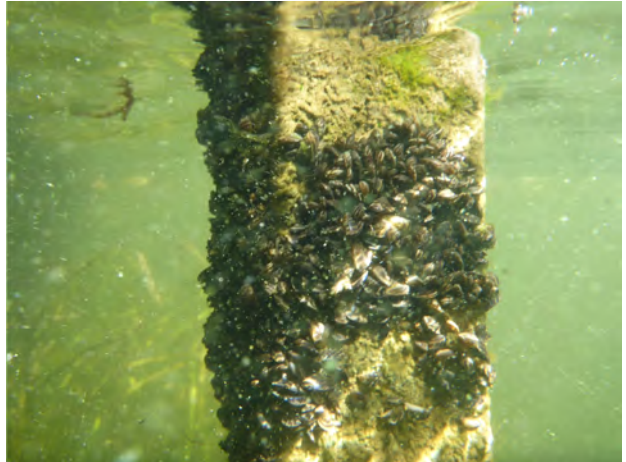
**September Conditions: Zebra mussels were found attached to aquatic plants and also growing on submerged substrate in Clearwater Lake in 2020.**
