## **Starry Stonewort Searches at Seven Boat Accesses for Clearwater Lake, Wright County, Minnesota, 2023**

**Survey Dates:**  
**1<sup>st</sup> Search: July 28, 2<sup>nd</sup> Search September 13,  
and 3<sup>rd</sup> Search October 16 and 17, 2023**

**Prepared for:**  
Clearwater Lake Property  
Owners Association

**Prepared by:**  
Steve McComas  
Jo Stuckert  
Connor McComas  
Blue Water Science  
St. Paul, MN

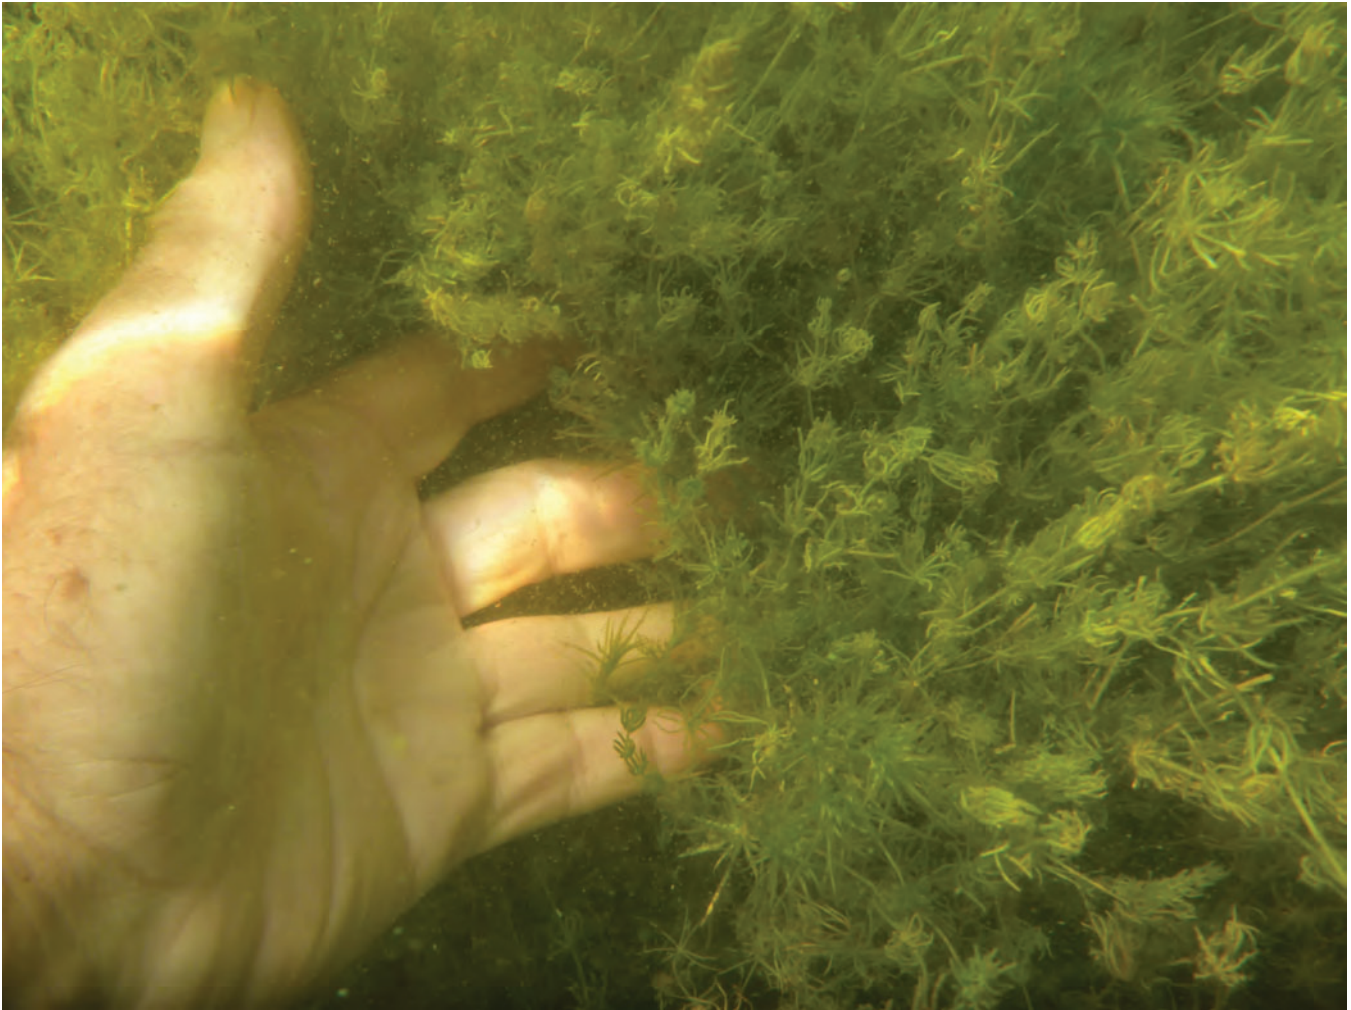
Chara in Clearwater Lake on July 28, 2023

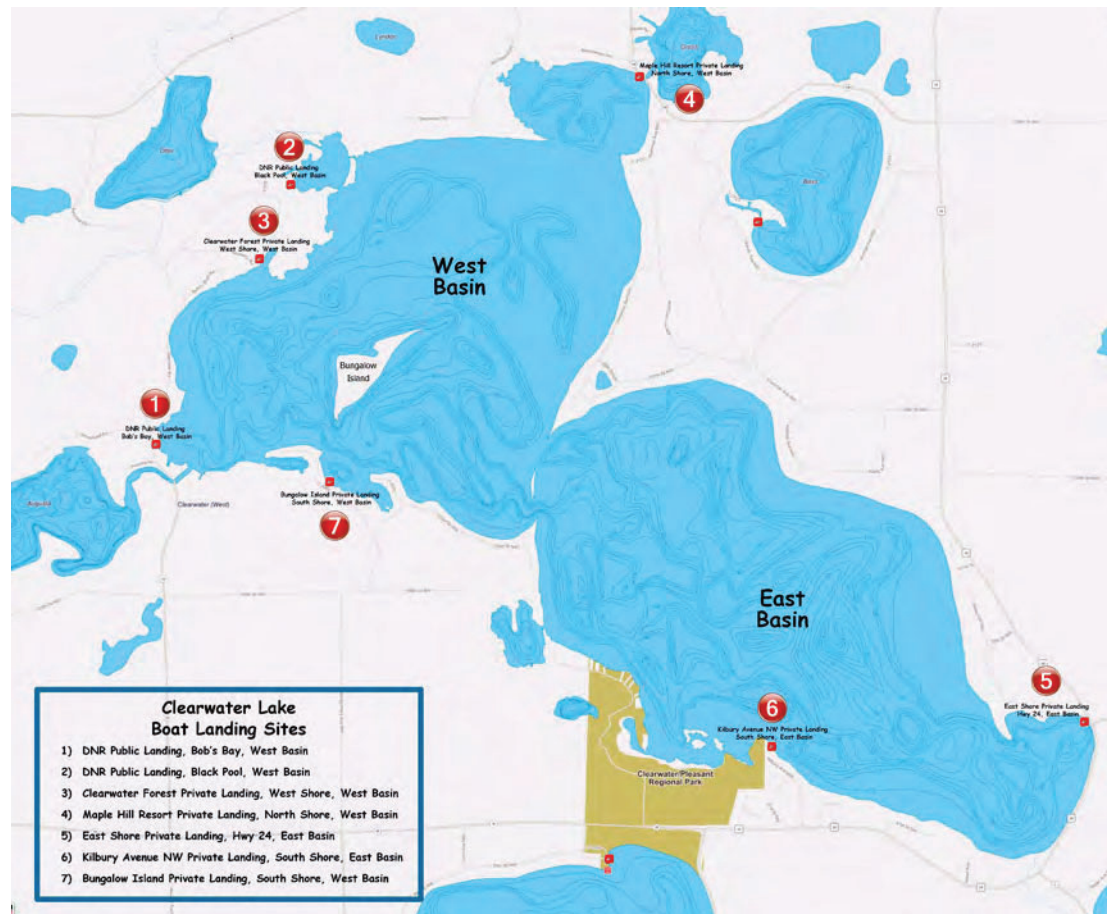
Figure 1. Location of the access search sites.

**Summary of the 2023 searches:** Staff from Blue Water Science, surveyed 7 boat accesses on July 28, 2023 (Figure 1). A combination of snorkeling and scuba diving (a total of 8.5 search hours) were conducted (Table 1). No starry stonewort was observed at any location.

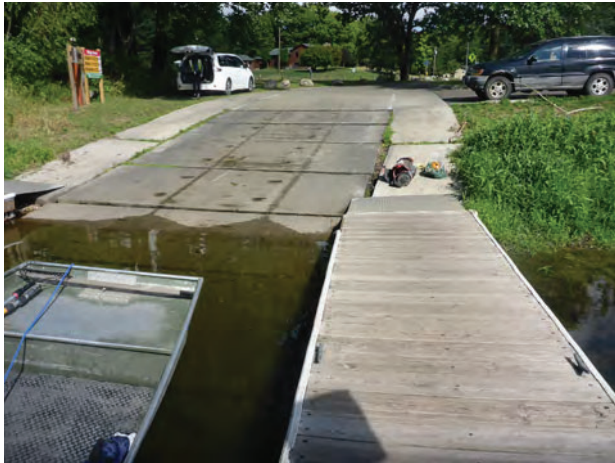
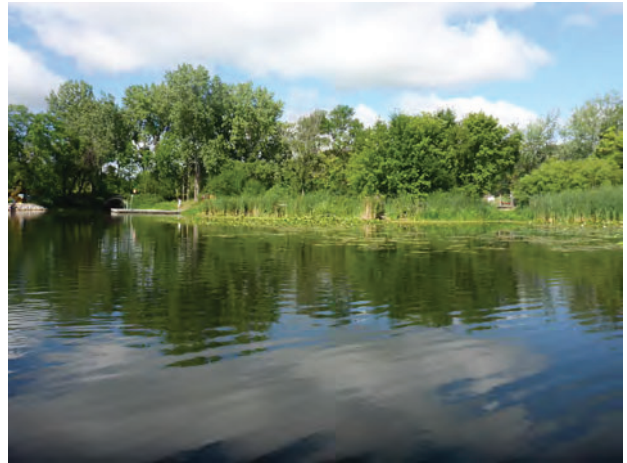
Bobs Bay Public Access

Representative Rake Sampling and Diving	Starry Stonewort (SSW)	Aquatic Plant Notes	Bottom Conditions
<b>July 28, 2023</b>				
1. Bob's Bay Access	60 minutes of diving	No SSW found	Coontail dominant, Purple loosestrife present, Filamentous algae common	Organic sediments and silty sand

1. Bob's Bay Access	15 minutes of diving	No SSW found	limited plant growth, limited habitat for SSW, heavy filamentous algae	Sand, gravel, cobble in landing area, mucky outside landing area

1. Bob's Bay Access	20 minutes of diving	No SSW found	limited plant growth, limited habitat for SSW, heavy filamentous algae	Sand, gravel, cobble in landing area, mucky outside landing area

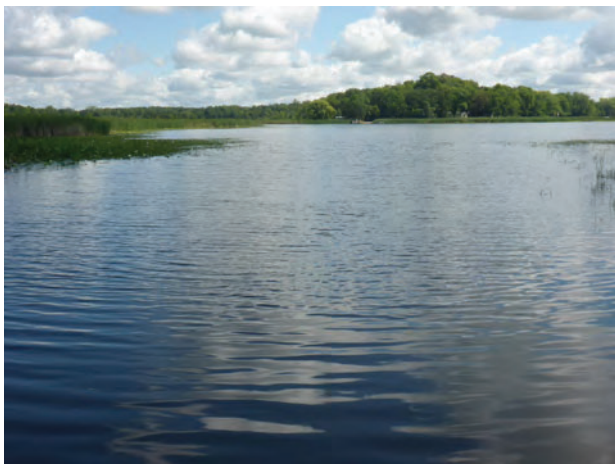
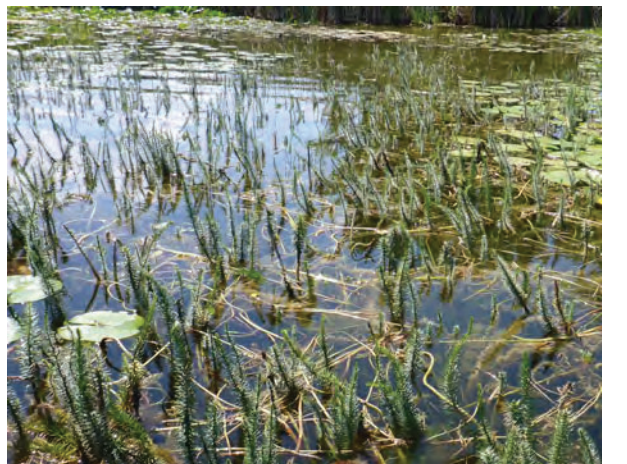
Black Pool Public Access

2. Black Pool Access	60 minutes of diving	No SSW found	EWM fragments present, wild rice and Mare's tail present, NWM present	Mostly silty sand, some scattered rocks

(Mare's tail)

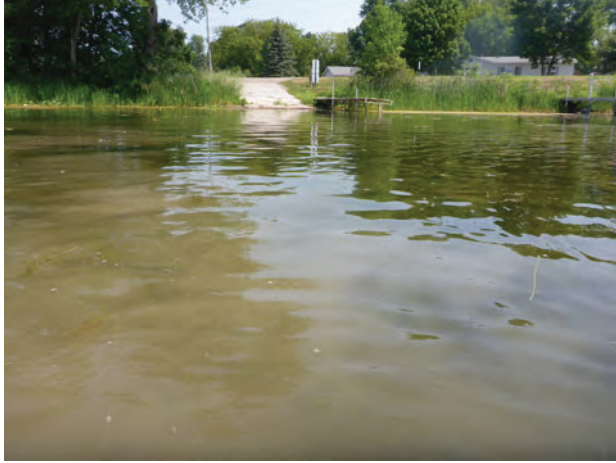
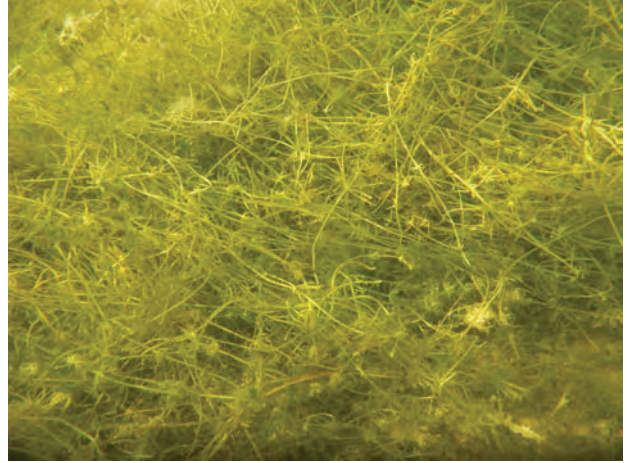
Maple Hill West Access

4. Maple Hills West Access	60 minutes of diving	No SSW found	Abundant plant growth, no milfoil, chara abundant	Shallow landing, silty sand
5. East Shore (Highway 24) Private Access	70 minutes of diving	No SSW found	Coontail abundant, chara common.	Mostly sand with some gravel

4. Maple Hills West Access	15 minutes of diving	No SSW found	Abundant plant growth, good diversity	shallow access
5. East Shore (Highway 24) Private Access	30 minutes of diving	No SSW found	Chara present, diverse plant community	Deep water, wind driven turbidity

4. Maple Hills West Access	20 minutes of diving	No SSW found	Abundant plant growth, good diversity	shallow access
5. East Shore (Highway 24) Private Access	20 minutes of diving	No SSW found	Chara present, diverse plant community	Deep water, wind driven turbidity

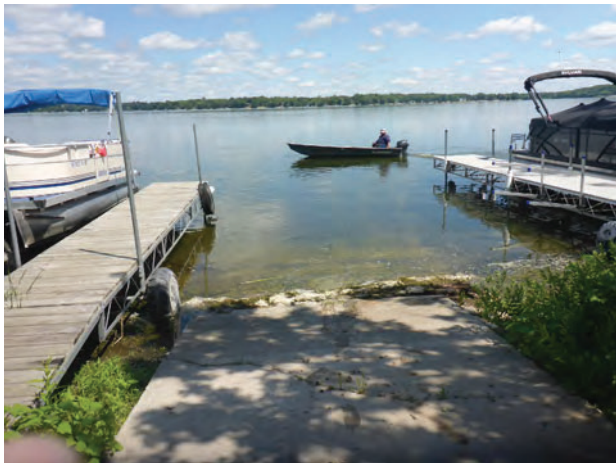
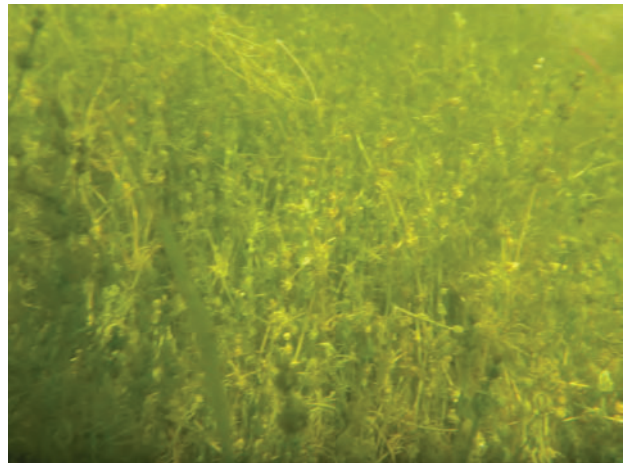
6. Clearwater East Access (Killbury Ave NE)	50 minutes of diving	No SSW found	NWM abundant, extensive chara beds. Clear water	Sandy changing to silty-sand

6. Clearwater East Access (Killbury)	40 minutes of diving	No SSW found	Abundant and dense chara. Suitable habitat for SSW.	shallow access
7. Bungalow Island	10 minutes of diving	No SSW found	Chara, claspingleaf pondweed, water celery common.	Shallow landing, silty with some soft muck sediments.
<b>October 16 and 17, 2023</b>

6. Clearwater East Access (Killbury)	20 minutes of diving	No SSW found	Abundant and dense chara. Suitable habitat for SSW.	shallow access
7. Bungalow Island	15 minutes of diving	No SSW found	Chara, claspingleaf pondweed, water celery common.	Shallow landing, silty with some soft muck sediments.

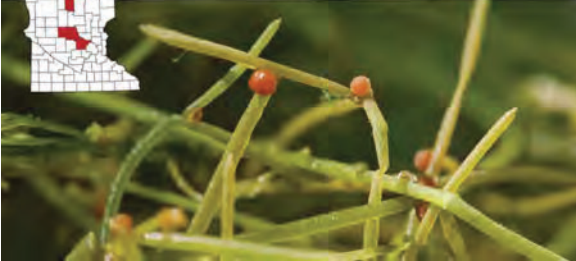
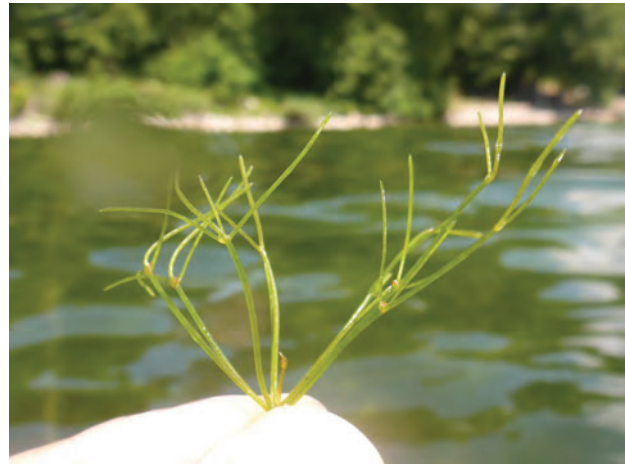
- Long, smooth branchlets are attached in whorls of 5 – 8
- Small, star-shaped bulbils form on clear threads at base of plant and may be found above or below the sediment surface
- Small, orange spheres called antheridia may be visible; these are male reproductive structures
- Typical branchlets are long; can be up to twelve inches
- Can form dense mats in water

*Actual size of bulbils*  
*Below, orange antheridia*

Figure 2. [left] Starry stonewort identification page from the University of Minnesota Aquatic Invasive Species Research Center (MAISRC). [left] Starry stonewort from Lake Koronis on July 31, 2017.

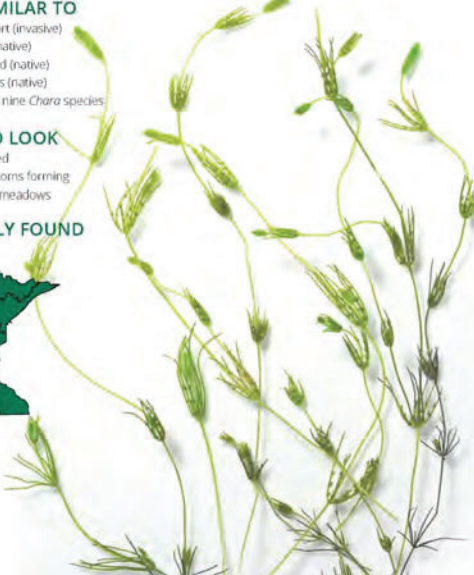
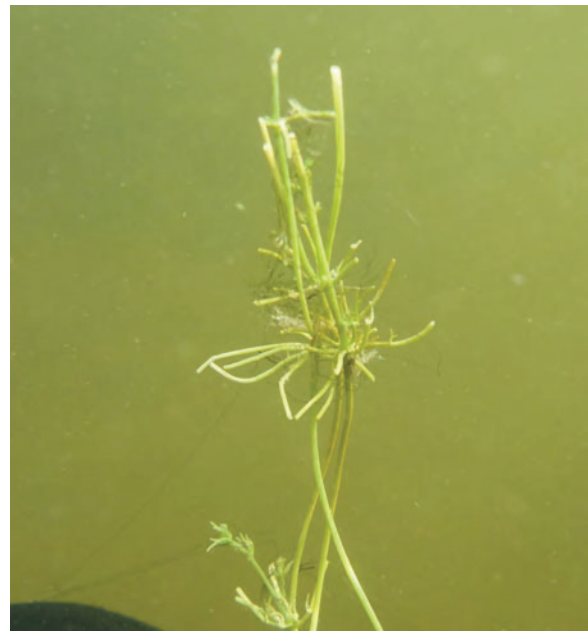
- Stems are typically rough and crunchy
- Thin branchlets form whorls around thin stems
- May produce bulbils, but not star-shaped
- May have musky odor

*Rough stems; whorled branchlets*

Figure 3. [left] Chara identification page from the MAISRC. [right] Starry stonewort looks a lot like some growth forms of chara. Starry stonewort was not observed in Clearwater Lake in 2022. The photo is chara from Clearwater Lake.
