## **Curlyleaf Pondweed and Eurasian Watermilfoil Delineation and Assessment for Clearwater Lake, Wright County, 2023**

**Prepared for:**  
**Clearwater Lake Property  
Owners Association,  
Annandale, Minnesota**

**Prepared by:**  
**Steve McComas  
Blue Water Science  
St. Paul, MN 55116**

**July 13, 2023**

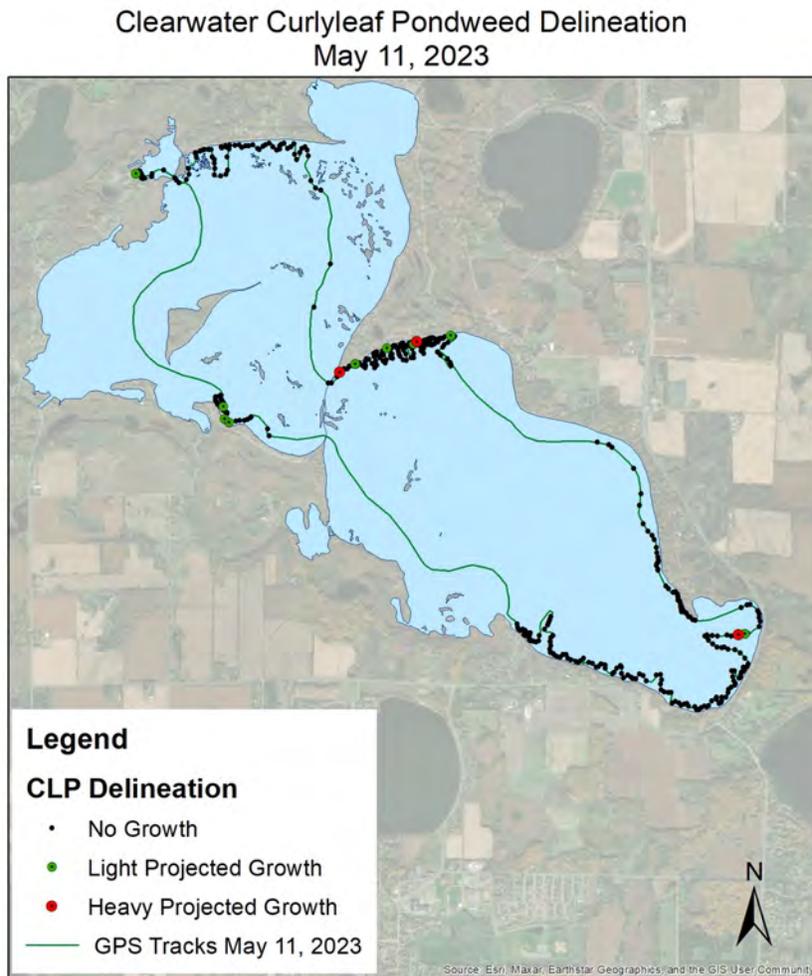
**Curlyleaf Pondweed (CLP) Delineation and Assessment:** Clearwater Lake (MnDNR ID#86-025200) is a 3,189 acre lake in Wright County, Minnesota. Early season CLP distribution and abundance were evaluated May 11, 2023 (Figure 1). Curlyleaf pondweed was found at 12 locations with growth densities of light to heavy. Based on the moderately light CLP growth no treatment was recommended for 2023.

**Figure 1. DELINEATION:** Map of curlyleaf pondweed distribution from the May 11, 2023 survey. No treatment was recommended for 2023. Key: green dots = light growth, red dots = heavy growth, and black dots = no curlyleaf growth.

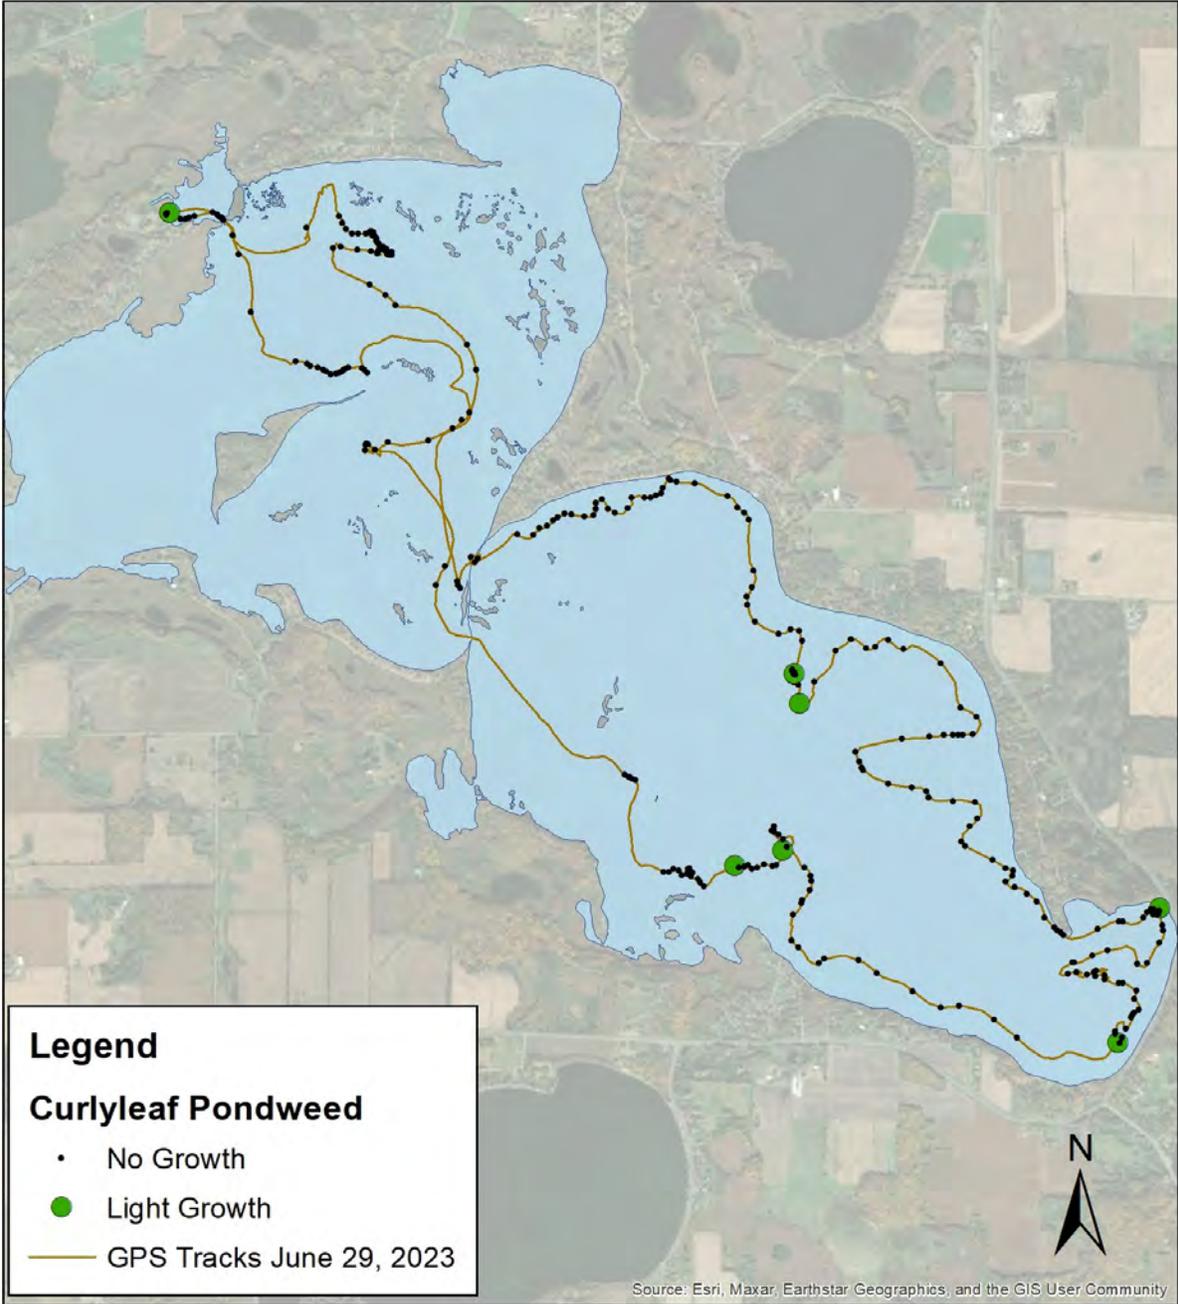
# Clearwater Curlyleaf Pondweed Growth June 29, 2023

A CLP assessment was conducted on June 29, 2023 which would be peak CLP abundance timeframe. The June CLP assessment found CLP in 7 areas with light growth. No heavy or moderate CLP growth was observed in 2023 (Figure 2).

Figure 2. ASSESSMENT: Map of curlyleaf pondweed assessment sites for June 27, 2022. Key: green dots = light growth, red dots = heavy growth, and black dots = no curlyleaf growth.

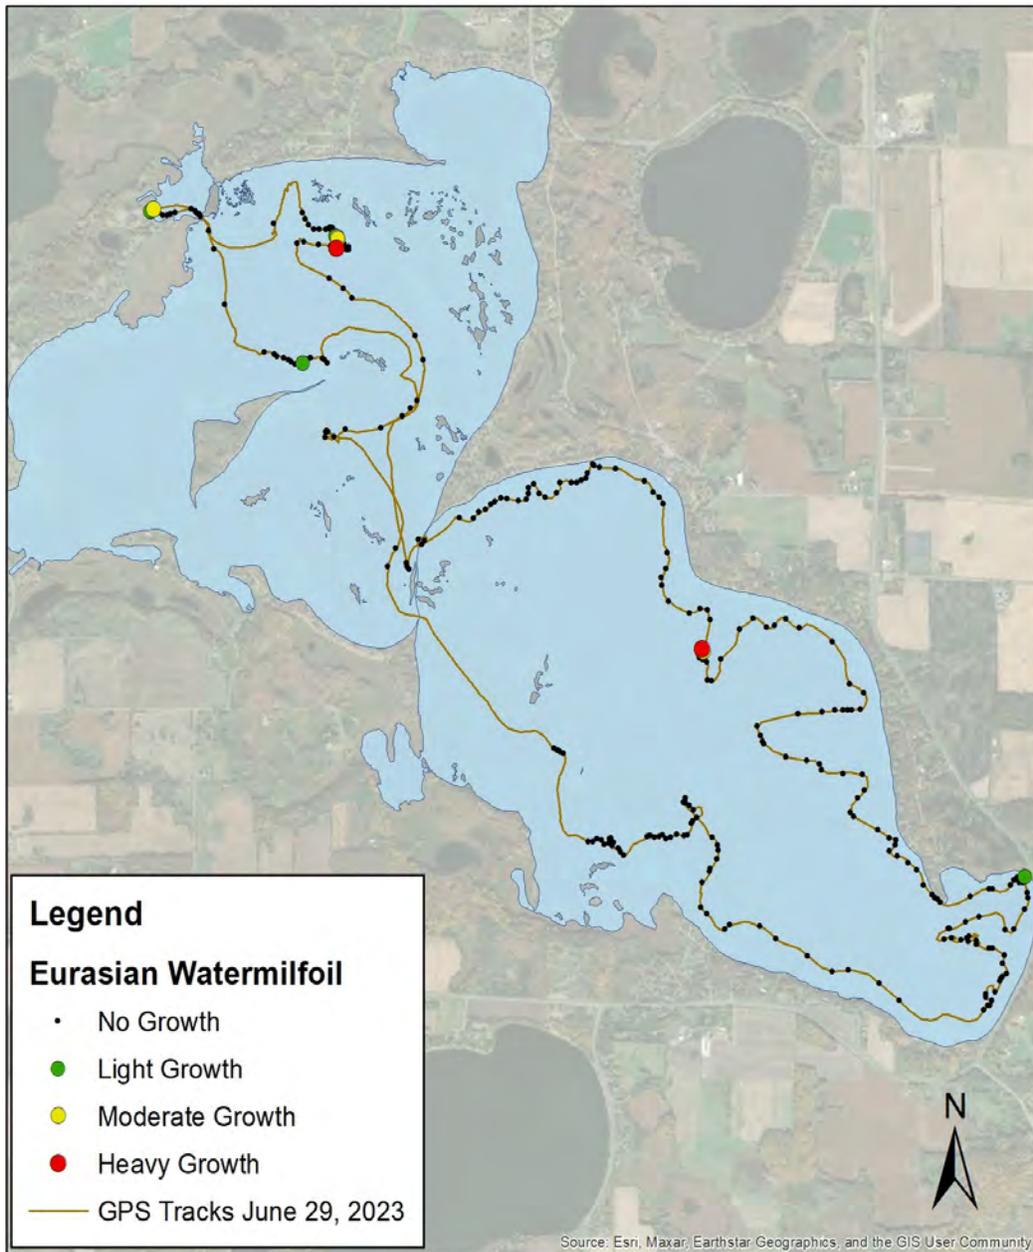
### Clearwater Eurasian Watermilfoil Delineation June 29, 2023

**Eurasian Watermilfoil (EWM) Delineation:** EWM distribution and abundance were evaluated June 29, 2023 (Figure 3). Several root crowns of Eurasian watermilfoil were sampled at 2 sites (red dots in Figure 3). Growth was light to moderate at three other sites. Areas with EWM were generally less than 400 sq ft (0.01 acres) and often embedded within native plants. Even if EWM was selectively eliminated, native plants would still be abundant and there would not be much notable difference in the plant density. EWM does not present a recreational nor ecological problem at this time. Based on results of the delineation, no treatment was recommended for 2023.

Figure 3. DELINEATION: Map of EWM distribution from the June 29, 2023 survey. No treatment was recommended for 2023. Key: green dots = light growth, yellow dots = moderate growth, red dots = heavy growth, and black dots = no curlyleaf growth.

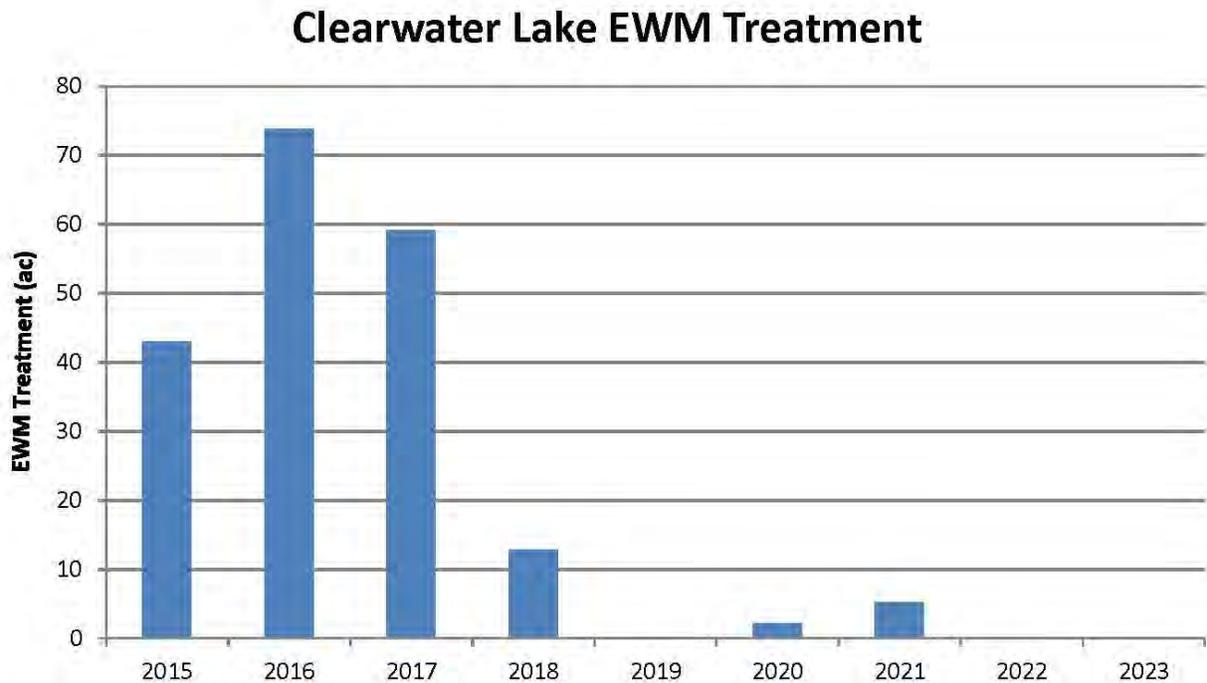
Eurasian watermilfoil was discovered in Clearwater Lake in 1989. From 2015 through 2023, EWM treatments have ranged from 2.24 acres to 73.8 acres (Table 1). The greatest number of acres treated were in 2016 (Figure 4). No EWM treatment has occurred in 2022 or in 2023.

**Figure 4. EWM treatments from 2015 through 2023.**

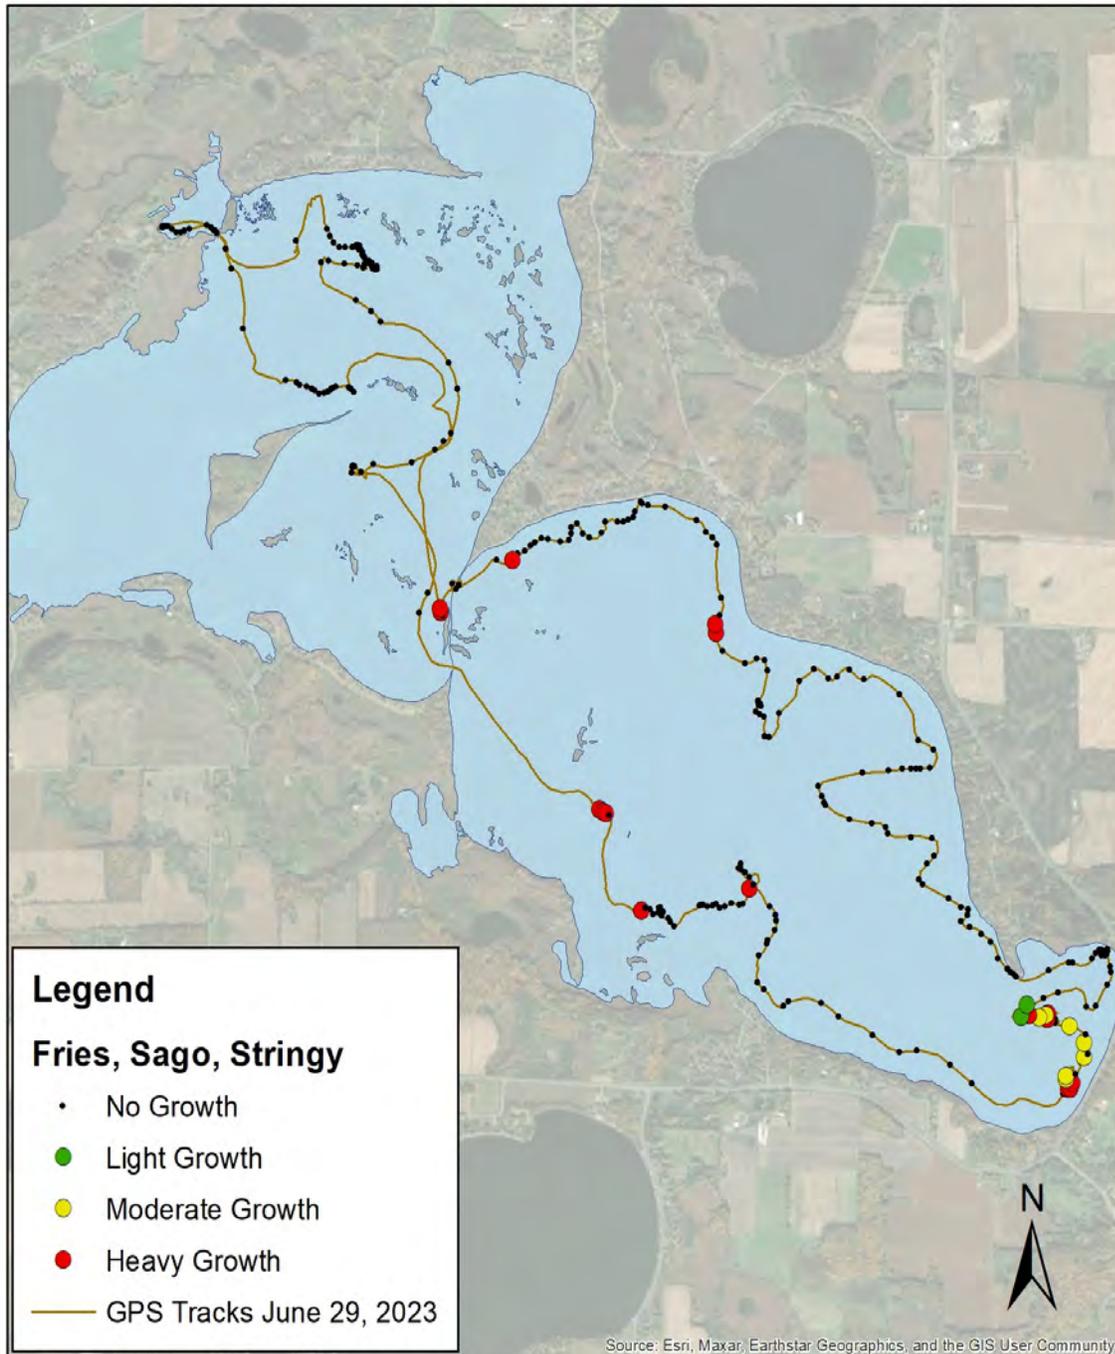
### Clearwater Stringy and Narrowleaf Pondweed Growth June 29, 2023

**Native Aquatic Plant Assessment:** A number of areas in Clearwater Lake had abundant native plant growth (Figure 5). Clear water has promoted robust plant growth in some areas in Clearwater Lake. Some sites will have native plants reaching the lake surface. No non-native plants such as EWM are growing this heavy at this time.

Figure 5. Native aquatic plants, stringy pondweed and narrowleaf pondweed, had some heavy growth in multiple areas in Clearwater Lake on June 29, 2023.

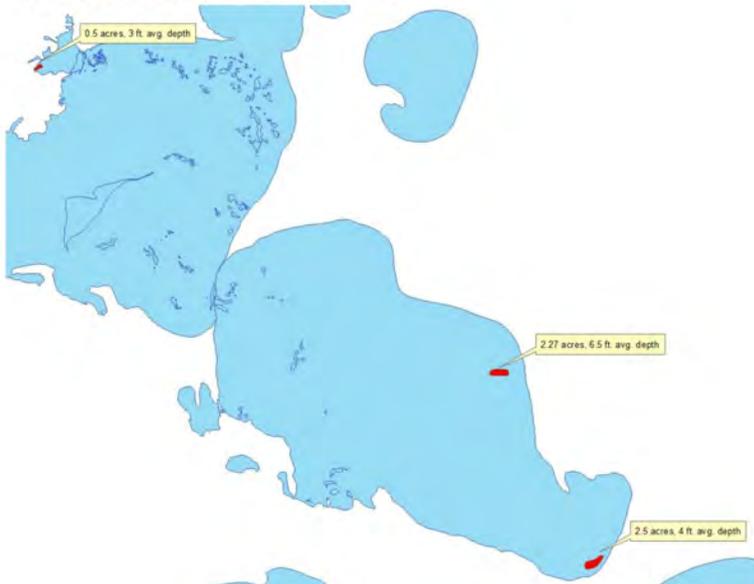
Figure 4. Clearwater Lake 2021 EWM Areas (5.27 acres)

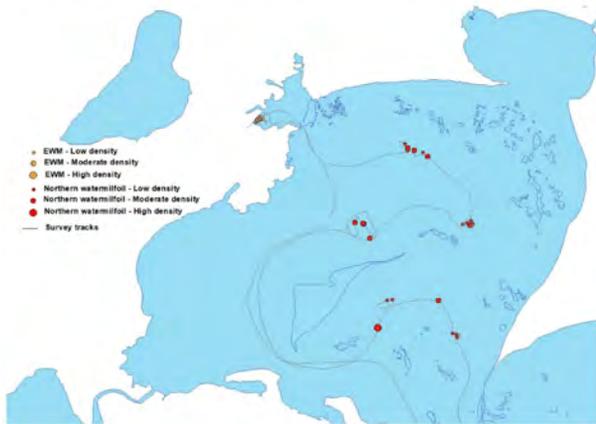
Figure 2. EWM distribution Clearwater Lake west basin from July 29, 2020

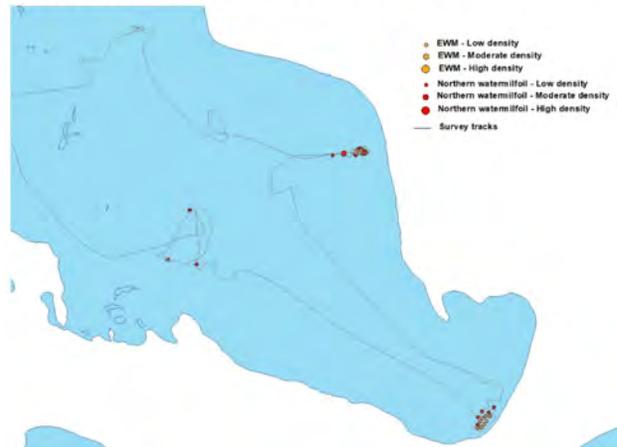
Figure 3. EWM distribution Clearwater Lake east basin from July 29, 2020

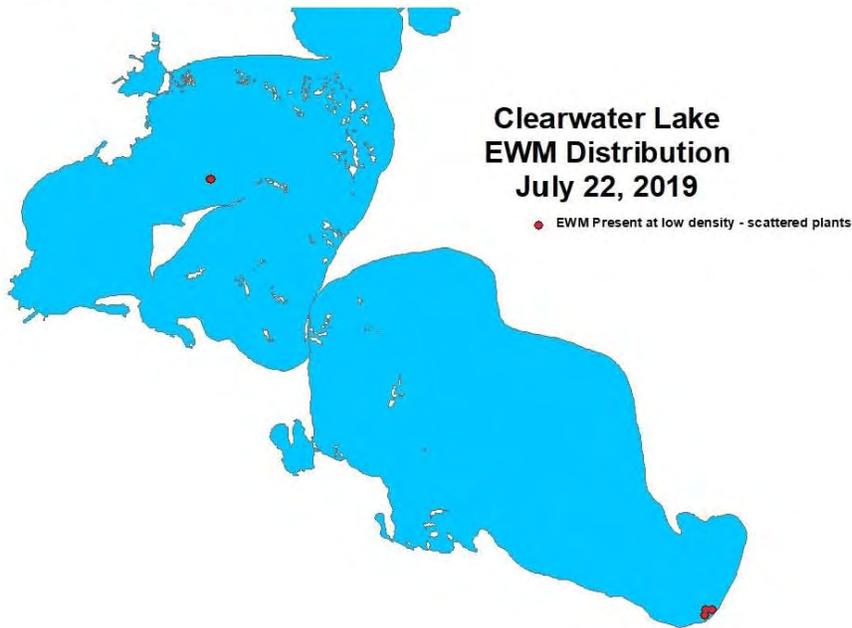
Figure 3. EWM distribution from July 22, 2019 survey

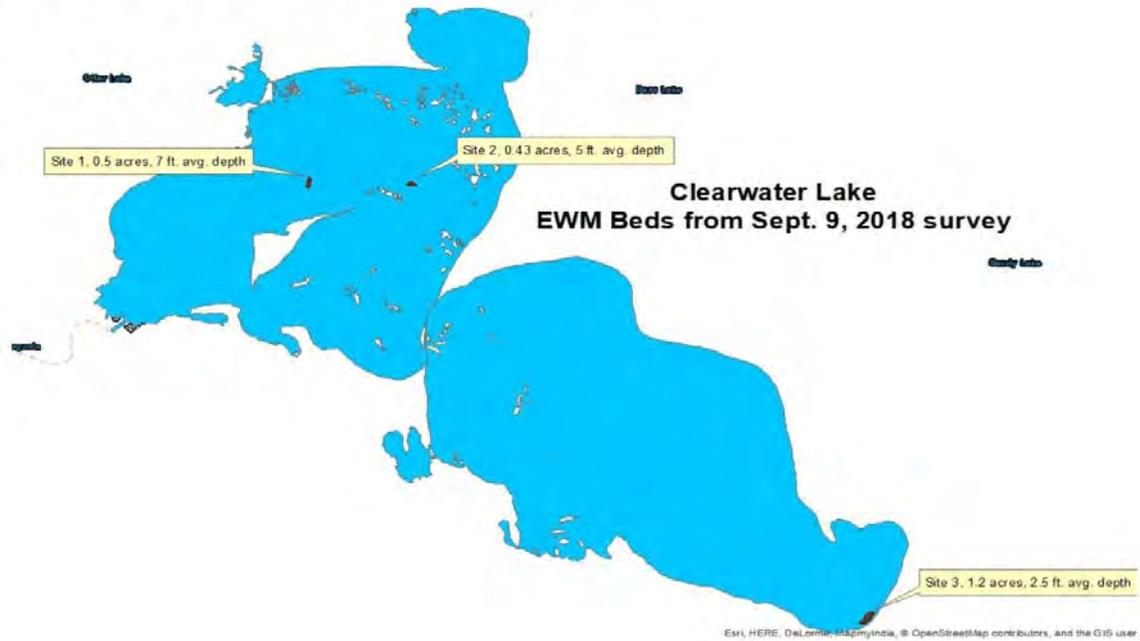
Figure 6. EWM Beds observed from 9/9/18 survey
