Clearwater Lake (Wright County)

Eurasian Watermilfoil Delineation

July 22, 2019

Prepared for the Clearwater Lake Property Owners Association

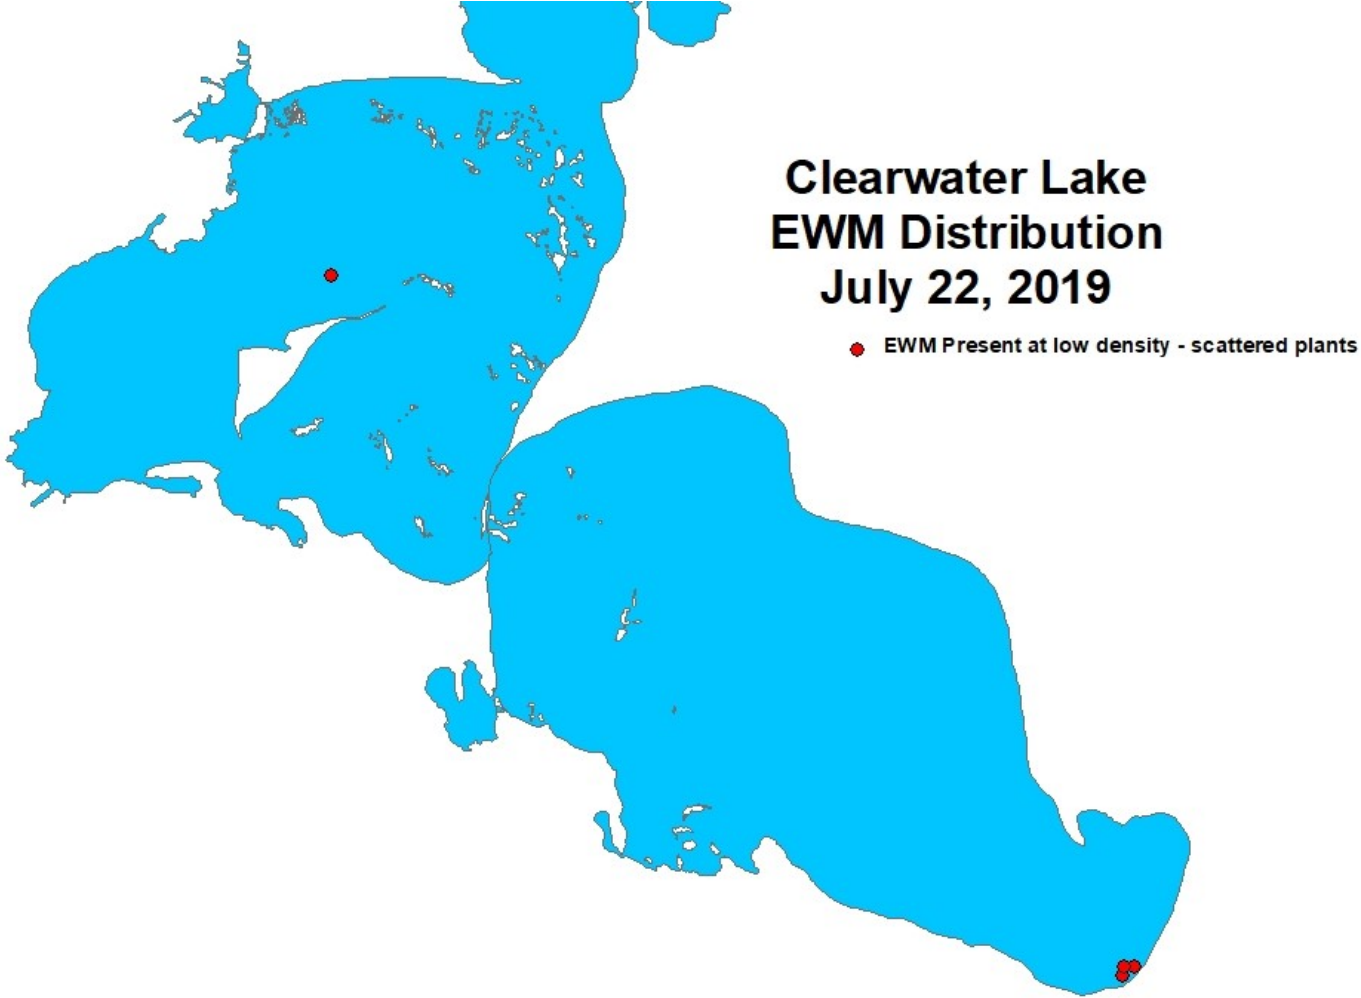
Figure 3. EWM distribution from July 22, 2019 survey

Very little Eurasian Watermilfoil was found. Scattered EWM was observed at two locations, as shown on Figure 3. Northern Watermilfoil and Coontail were both very common at many of the historical treatment areas. No treatment is recommended for 2019 based on the low abundance and density of EWM.
