Clearwater Lake
Point-Intercept Survey
June 25 & July 1, 6 and 8, 2017
Wright County
Annandale, MN
DOW# 86025200

Introduction

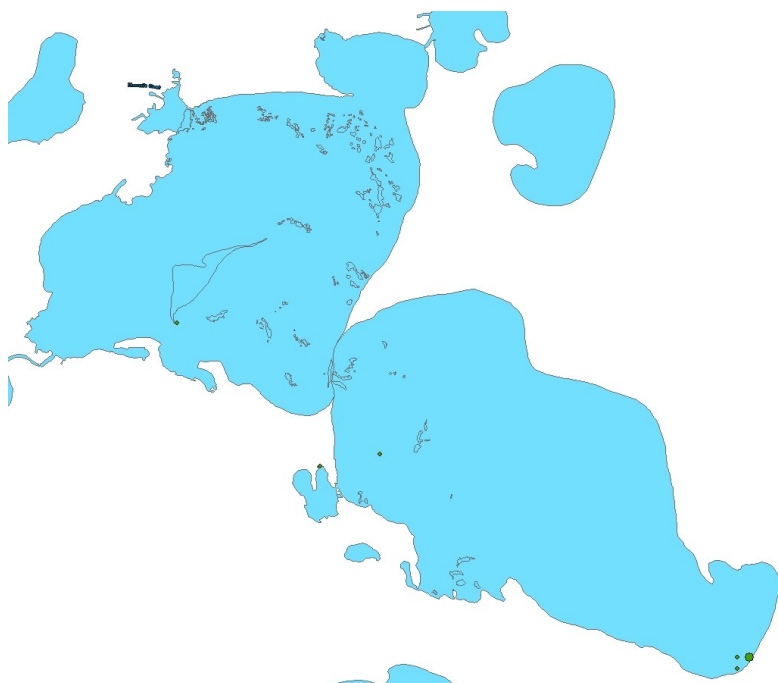
Eurasian Watermilfoil found from only point-intercept survey points. An additional map of all areas where Eurasian Watermilfoil was found, including areas in between and outside survey points, can be found on the next page of this report.

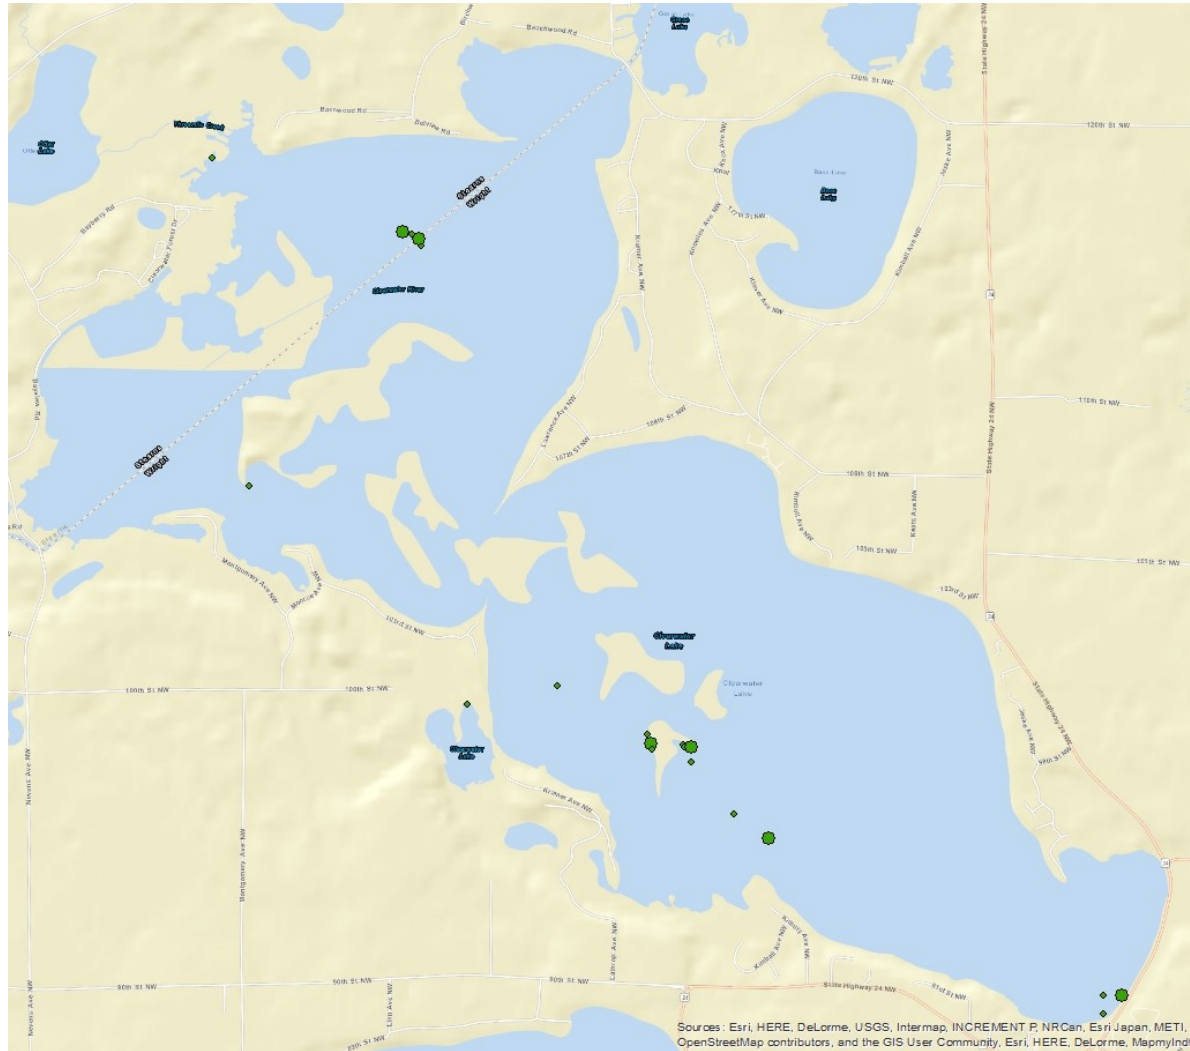
During the survey, additional areas in between and just outside the survey points were assessed for the presence of Eurasian Watermilfoil. Several small patches or scattered plants were found. While these observations cannot be used in the statistical analysis of the survey, they are still valuable for those working on vegetation management in the lake. This was not an exhaustive delineation of all Eurasian Watermilfoil in the lake, however, a lot of ground was covered during the survey and there were likely not any significant or overly abundant patches of Eurasian Watermilfoil not noted in the map below. It is likely, however, that there are more small scattered areas of Eurasian Watermilfoil around the lake that were not identified during the survey.
