Eurasian Water Milfoil Survey for Clearwater Lake Wright County, Minnesota September 13, 2017

Prepared for:
Clearwater Lake Association

Prepared by:
Kyle Blazek
Lake Restoration Inc.
Rogers, MN

Clearwater Lake EWM Post Treatment Survey September 2017

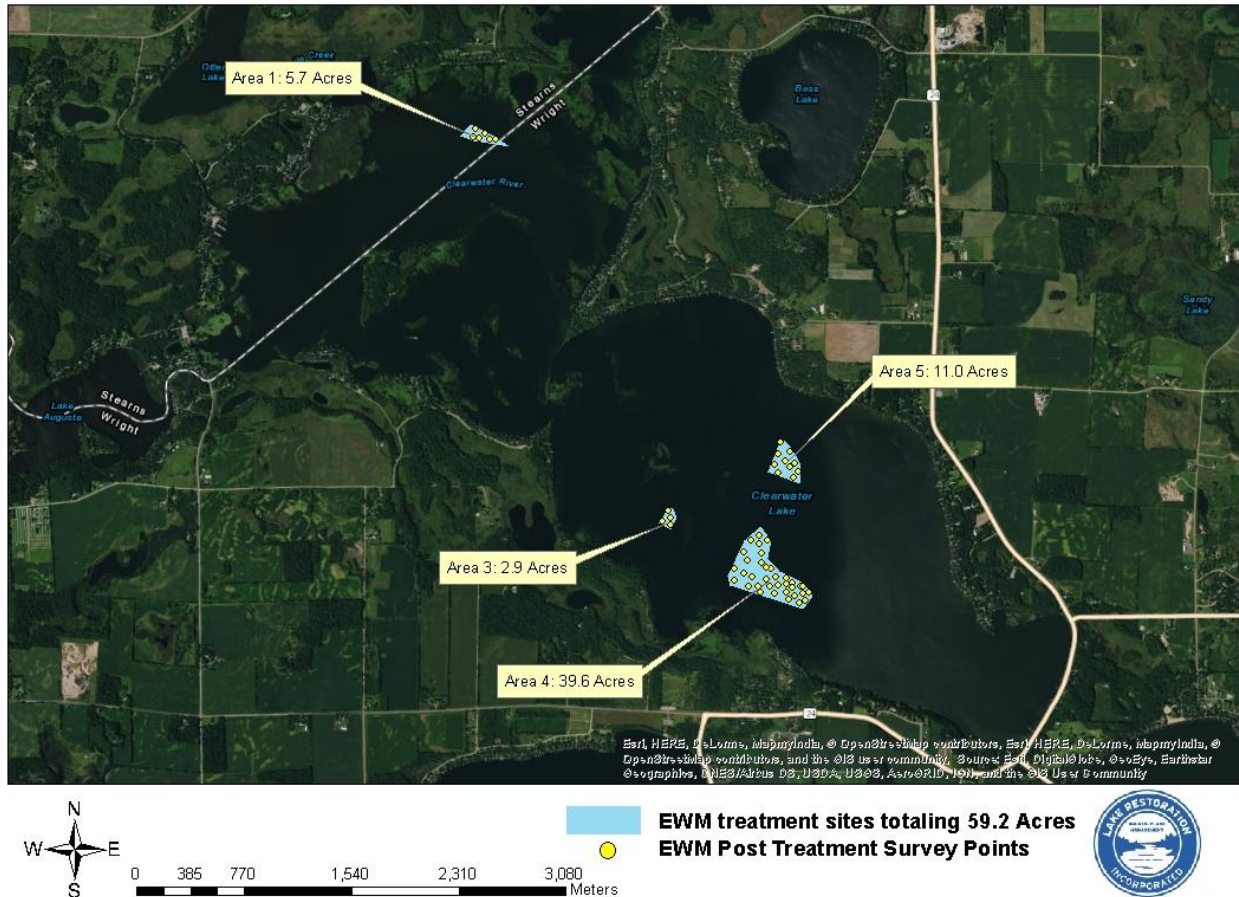
Treatment Site	Acres	Survey Points	Results
1	5.7	6	Few single strands of EWM spotted
3	2.9	4	No EWM found
4	39.6	35	No EWM found
5	11.0	10	No EWM found

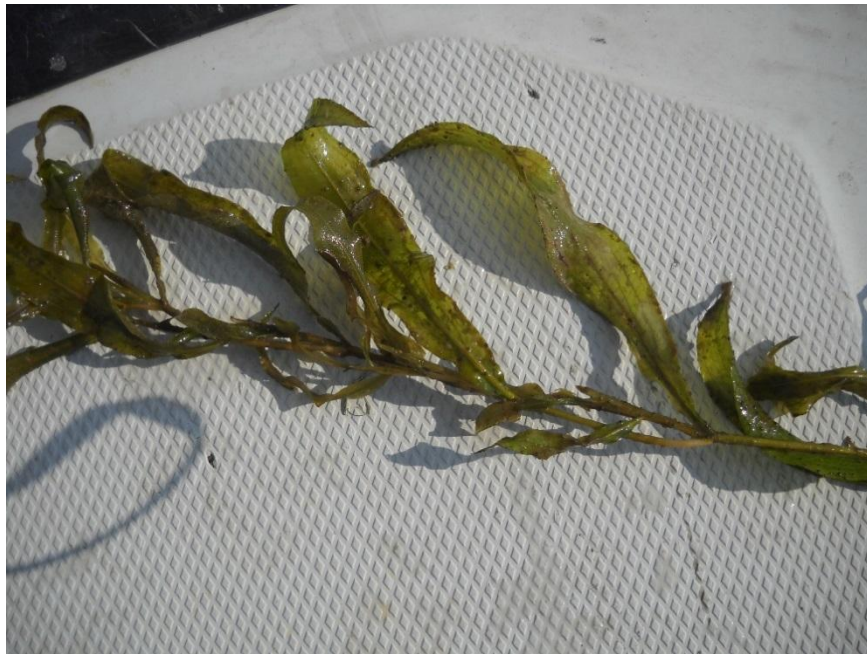
Figure 1: Clasp Leaf

Treatment site 4 had 35 survey points ranging in depth from 4 ft. to 33 ft. This treatment site was the largest and had a diverse structure throughout. Aquatic plants found from sampling included Chara, Coontail, Clasp Leaf (Fig. 1), Curly Leaf, Northern Watermilfoil (Fig. 5). Chara and Coontail were the dominate species and the other species were not very prevalent. No EWM were spotted or found during survey sampling in treatment site 4.

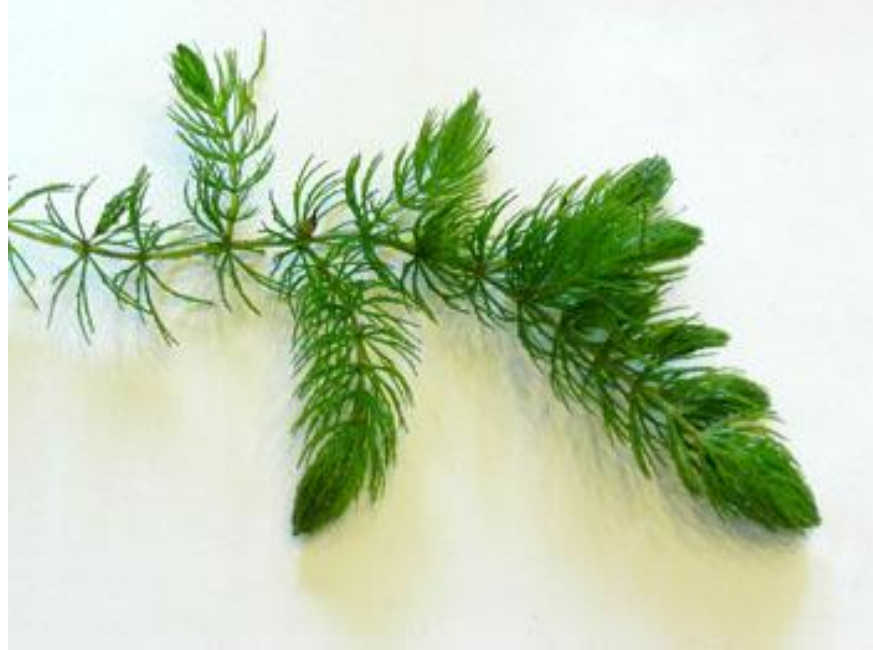
Figure 2: Coontail

Treatment site 1 had 6 survey points ranging in depth from 5.5 ft. to 23 ft. Aquatic plants found from sampling included Chara (Fig. 4), Coontail (Fig. 2), and Curly Leaf (Fig. 3) with Chara being the dominate vegetation found. Although EWM was not located by the rake during survey, shallow (3'-8') locations were spotted on the edge of treatment area or just outside of treatment area that showed single strands of EWM that rose to the surface. Locations spotted with EWM during survey were infrequent.
